MISSOURI RIVER
SECTION 32
STREAMBANK EROSION CONTROL

INTERIM FIELD EVALUATION
OF
WINDROW REVETMENT

MARCH 1980

U. S. ARMY ENGINEER DISTRICT, OMAHA

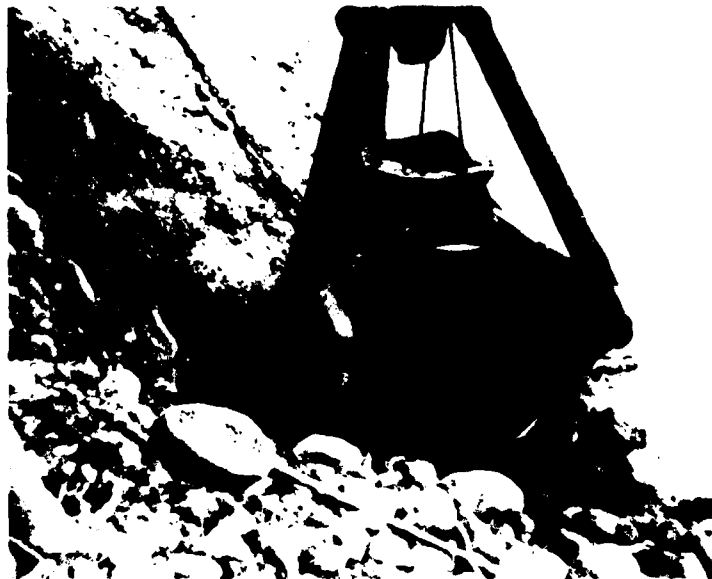
Photograph 10. View of equipment removing a sample of the windrow
revetment. Date: 2 Dec 1977

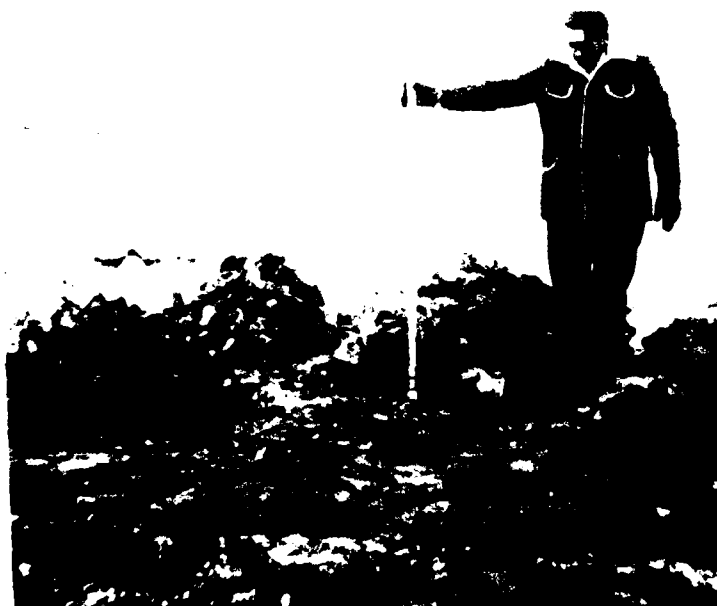
Photograph 12. View of sampled stone which had been sorted by hand with respect to size. Date: 2 Dec 1977

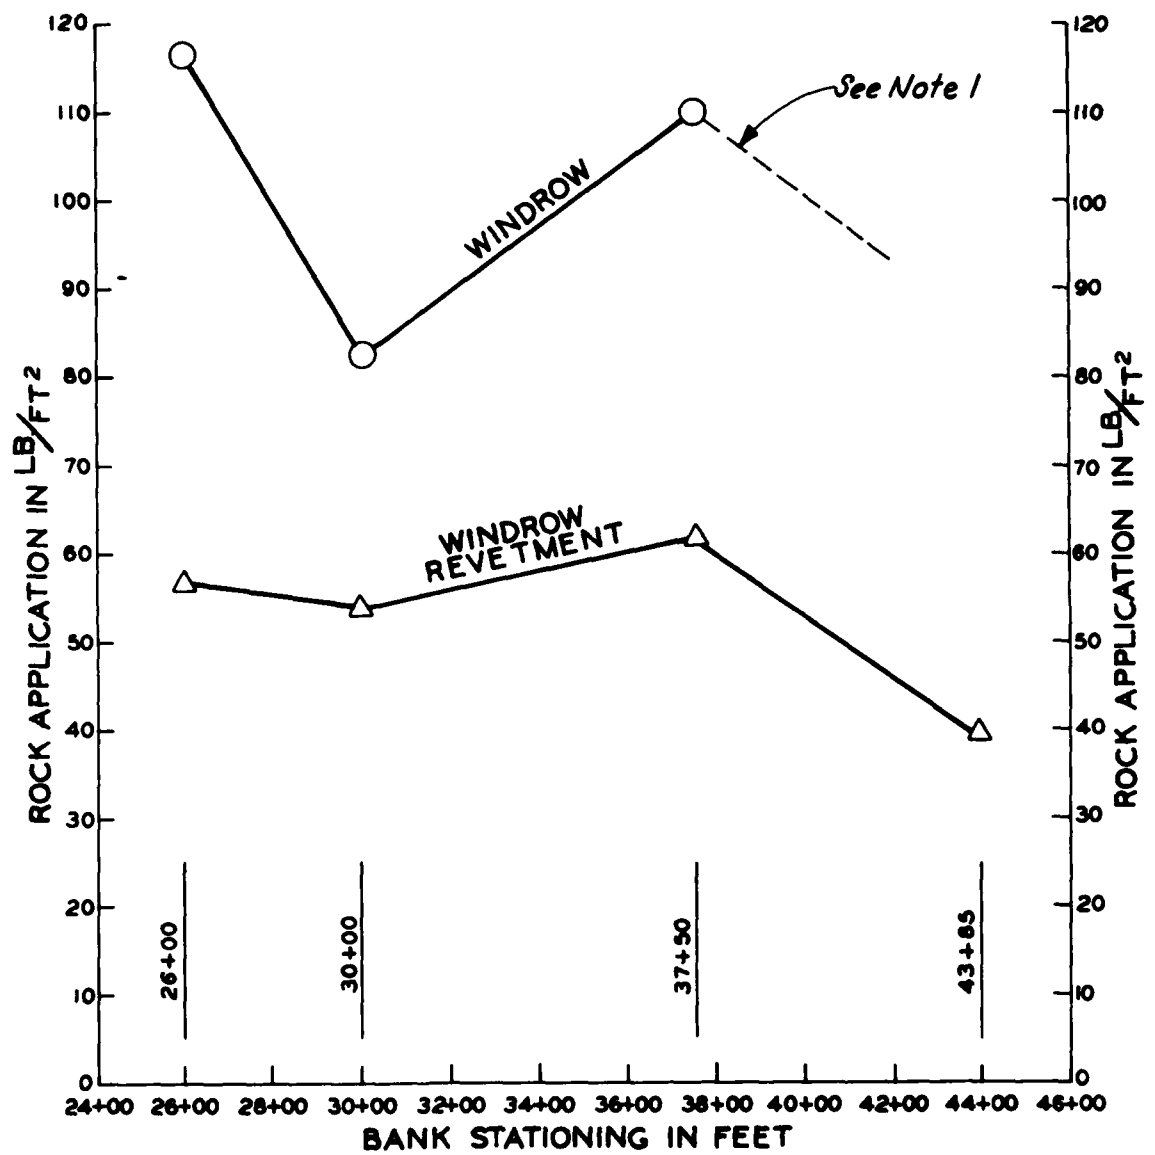
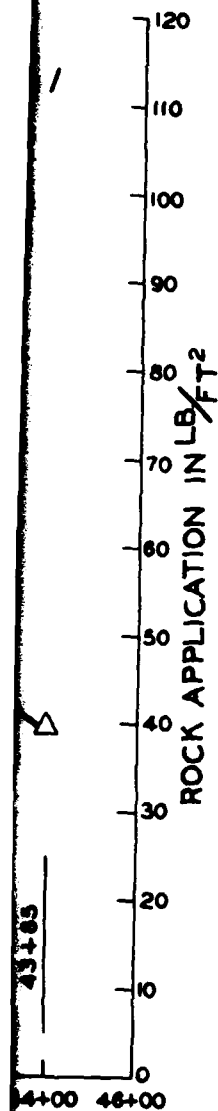
MISSOURI RIVER
SECTION 32 STREAMBANK EROSION CONTROL
BANK PROTECTION
USING WINDROW REVETMENT
ROCK APPLICATION GRAPH

1. AT BANK STATION 43+85 ALL FIELD-STONE MATERIAL IN THE WINDROW HAS BEEN USED ON THE WINDROW REVETMENT.
2. FIELD MEASUREMENTS WERE TAKEN 2 DEC. 1977.

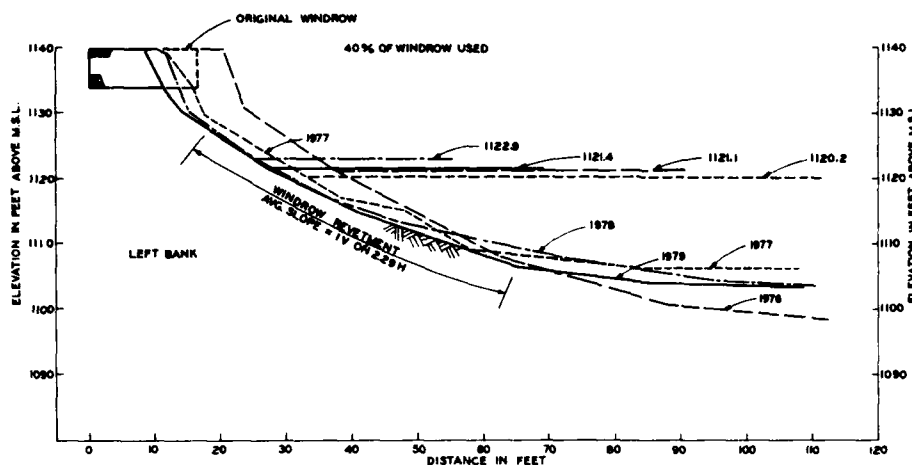
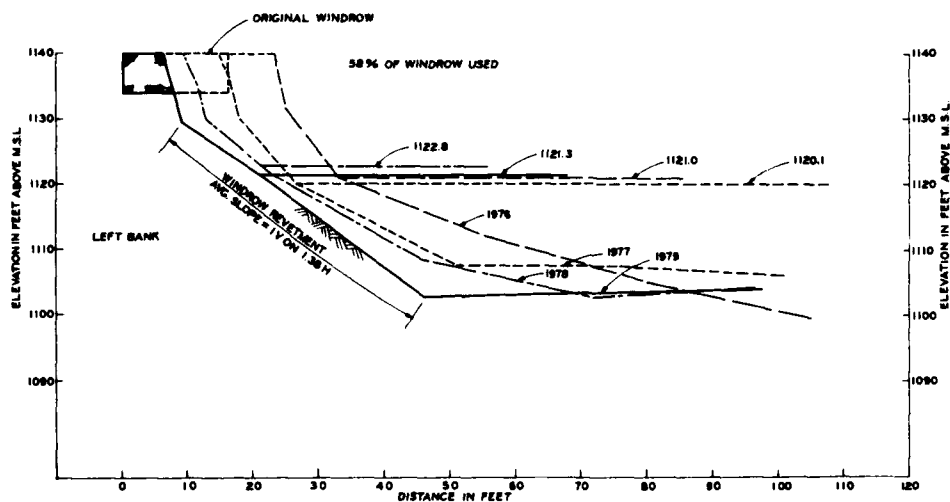
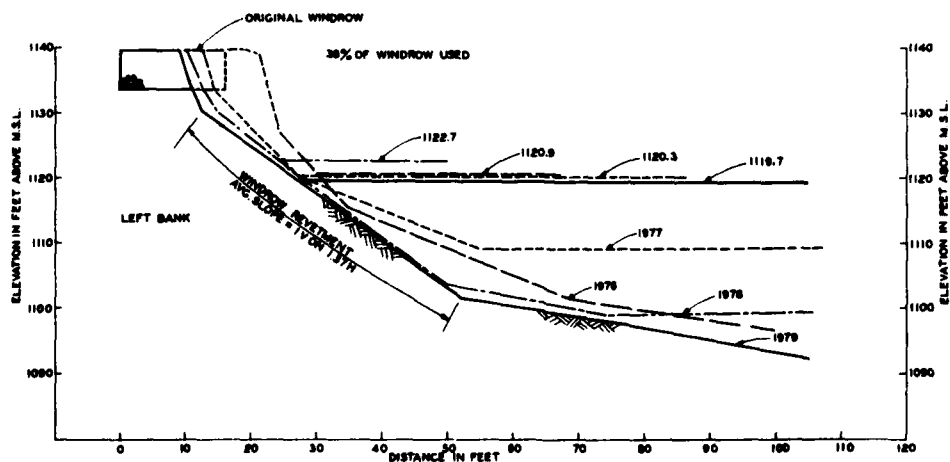
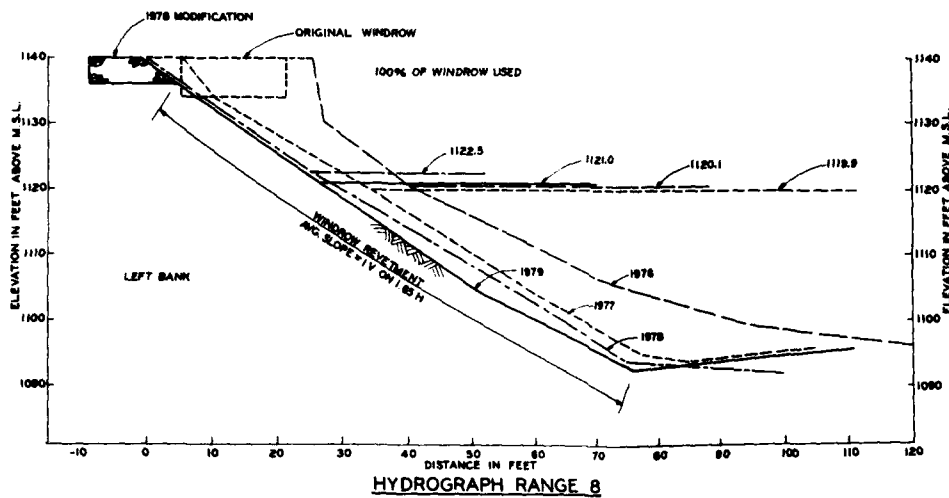
The changes in the configuration of the left channel bank along the study reach is shown on Plate 13. At nearly all the stations shown on this plate, degradation has occurred since construction of the project. The reduction in bank erosion is shown by comparing the vertical distances between the cross-sections of each year on the same graph. Hydrograph ranges 4 and 6 show almost no lateral erosion between 1978 to 1979.
